Guide to Evaluating Details for Susceptibility to Constraint-Induced Fracture

American Institute of Steel Construction

This guide explains how to evaluate steel bridge details for susceptibility to constraint-induced fracture (CIF). The guide is directly based on a technical report titled “Evaluation of Steel Bridge Details for Susceptibility to Constraint-Induced Fracture,” Report No. FHWA-HIF-21-046, published by the U.S. Department of Transportation (US DOT), Federal Highway Administration (FHWA), in September of 2021. In fact, most of the content of this guide is directly copied from that report, with minor editorial changes made to facilitate formatting and flow of the guide. In addition, direct statements were added regarding when the use of specific problematic details is not recommended. Significant portions of the FHWA report were omitted from this guide for brevity; readers interested in further information on the concepts of ductility and fracture and other background material can read the full FHWA report, which is available for free download from the FHWA website.

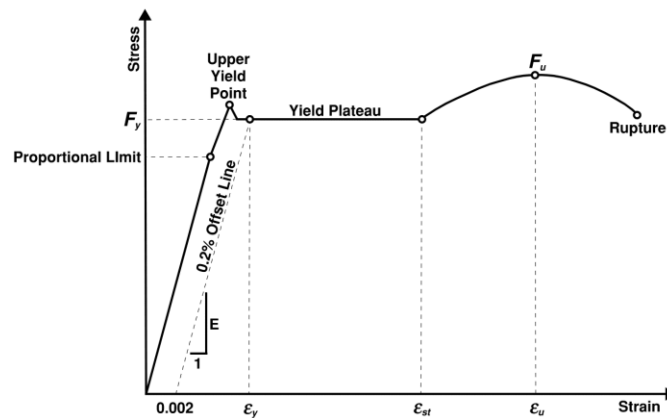
Figure 4 and Figure 5 show that significant plastic deformation may occur under loading between the uniaxial yield stress, F_y , and the ultimate tensile strength of the material, F_u , with further deformation occurring prior to rupture. This plastic behavior generally results in significant structural deformation prior to reaching the ultimate tensile strength of the material, providing warning of an impending failure. This is generally characterized as “ductile behavior;” that is, the material displays significant ductility prior to failure.

Figure 4. Engineering tensile stress versus strain curve for structural steel with a defined yield plateau.

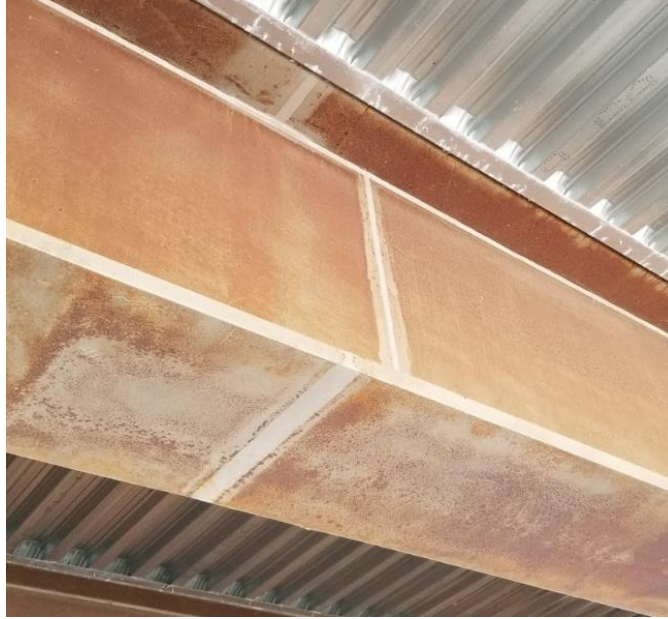
One of the most common bridge details featuring intersecting welds is the intersection of flange-to-web fillet welds with flange shop splices accomplished using CJP groove welds in butt joints. This situation is unavoidable in many bridge designs. The flange shop splice is generally accomplished prior to attaching the flange to the web. While there are clearly intersecting welds in this detail, both a qualitative evaluation and a long history of good performance support that this detail is not subject to an elevated susceptibility to CIF. See Figure 18 and Figure 19.

Figure 19. Steel plate girder with flange-to-web welds intersecting CJP groove welds in butt joints used to accomplish flange and web shop splices.

A similar, related detail involves the intersection of flange-to-web fillet welds with web shop splices accomplished using CJP groove welds in butt joints. This case of intersecting welds is also, for all practical purposes, unavoidable in many bridge designs. The web shop splice is generally accomplished prior to attaching the web to the flange. See Figure 19 and Figure 20.
