Guidelines for Field Repairs and Retrofits of Steel Bridges

G14.2—2023

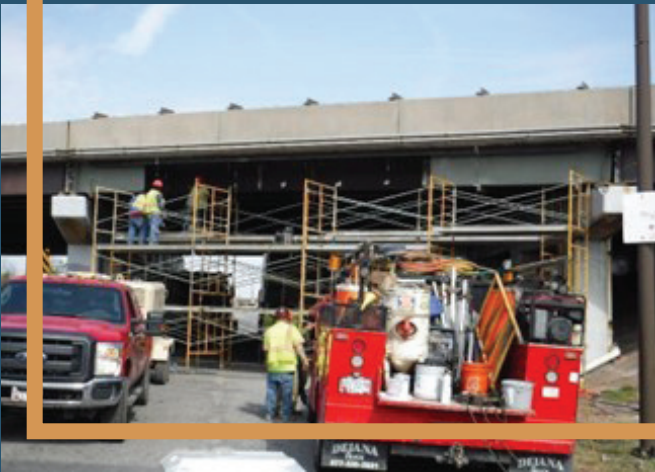
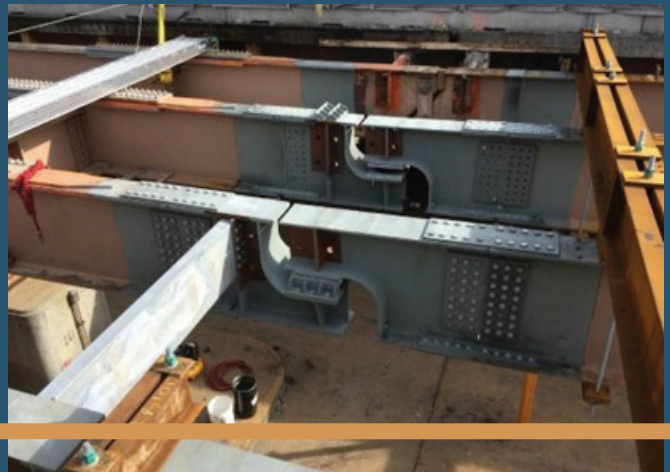
AASHTO/NSBA STEEL BRIDGE COLLABORATION

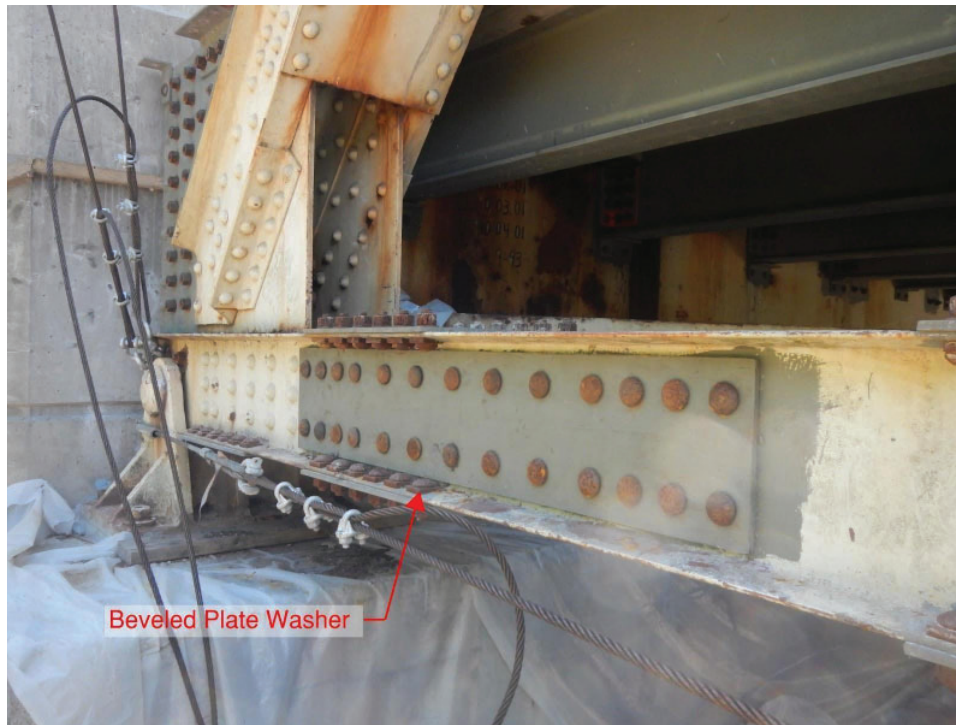
Figure 2-1—Truss bottom chord plating repair showing button-head bolts and beveled plate washers

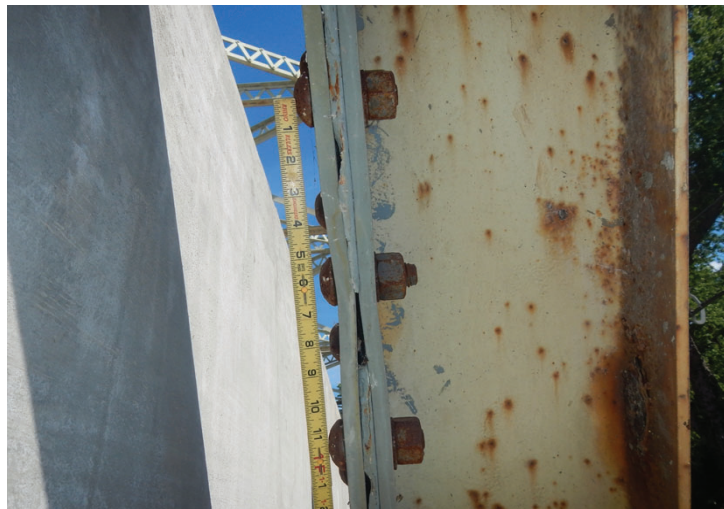
Figure 3-9—Plating repair with severe section loss and inadequately prepared irregular surface

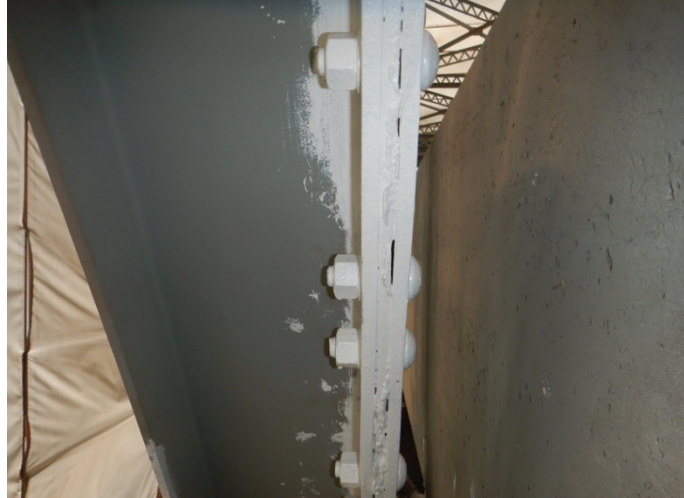
Figure 3-10—Plating repair where epoxy filler hardened prior to plate installation

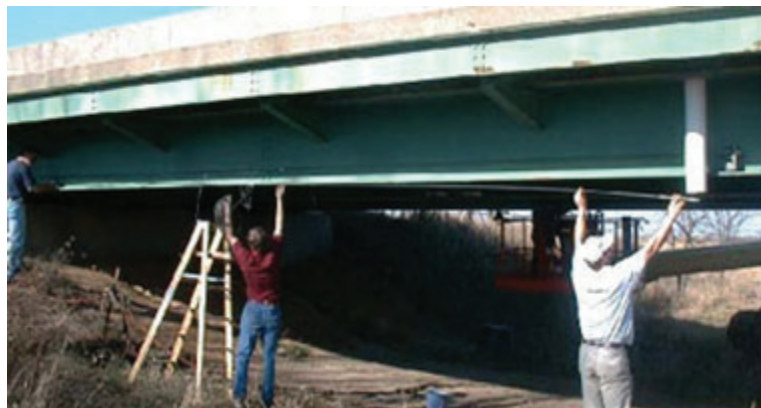
Figure 3-12—Application of FRP bar for bridge repair (Wipf et al., 2003)

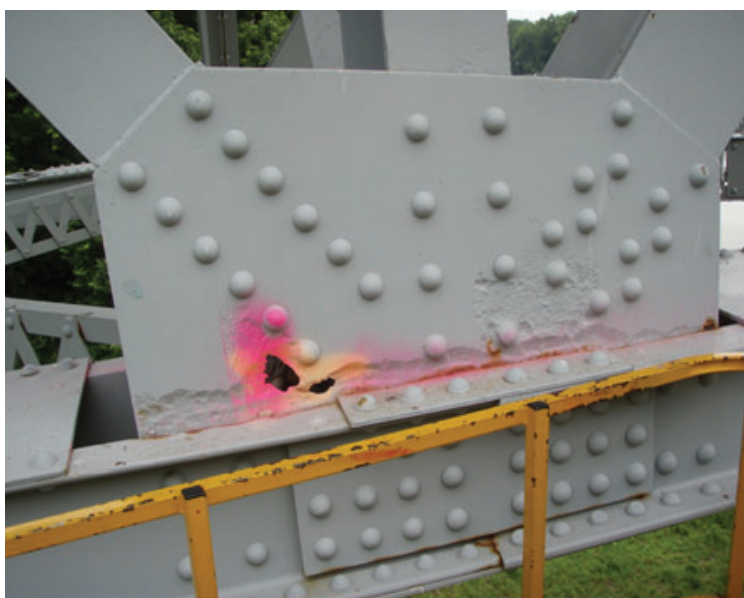
Figure 3-14—Gusset plate connection with severe pitting and through-thickness loss along the horizontal plane located just above the truss bottom chord

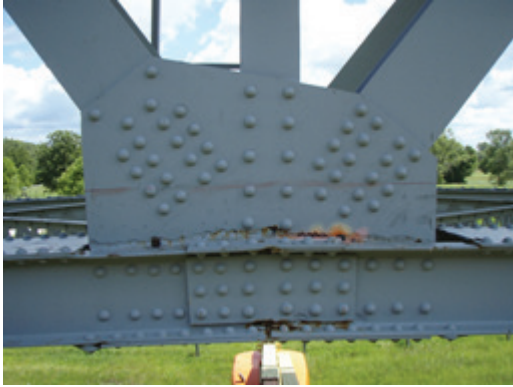
Figure 3-18—Field-verifying repair dimensions

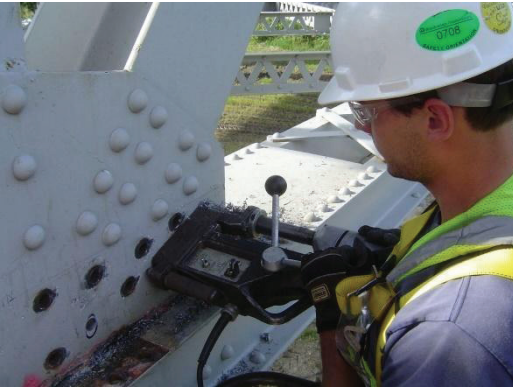
Figure 3-20—Removing existing fasteners and drilling holes

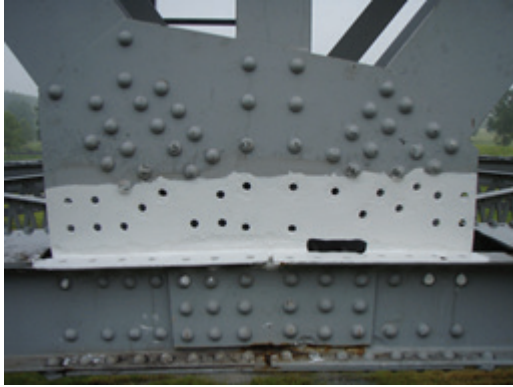
Figure 3-23—Coating exposed steel surfaces

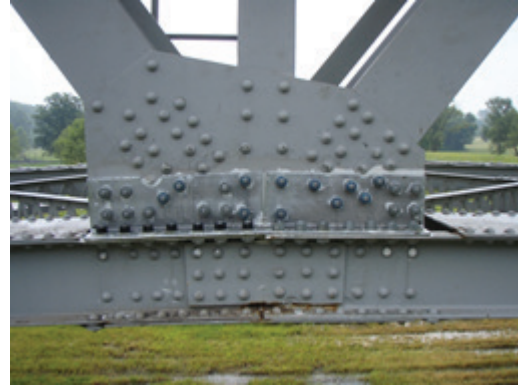
Figure 3-24—Installing steel repair and tightening bolts

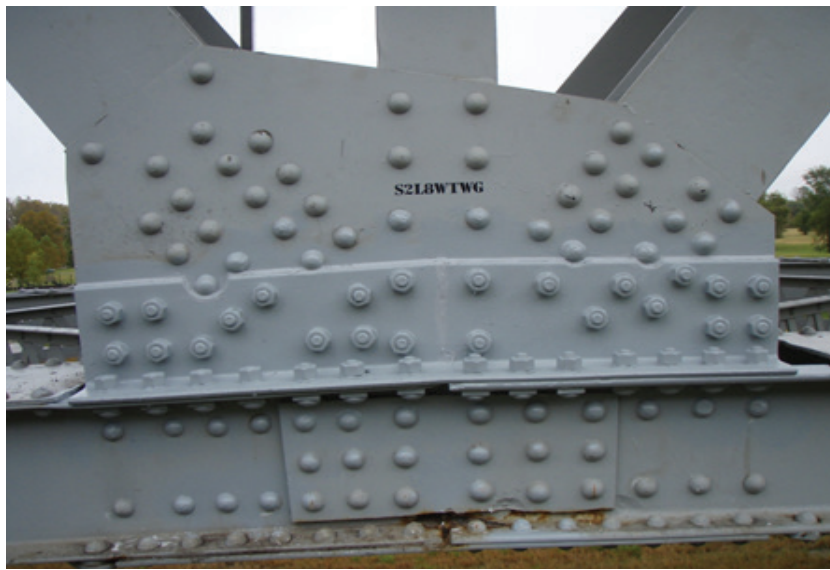
Figure 3-25—Final repair installation after sealing contact surfaces and application of topcoat

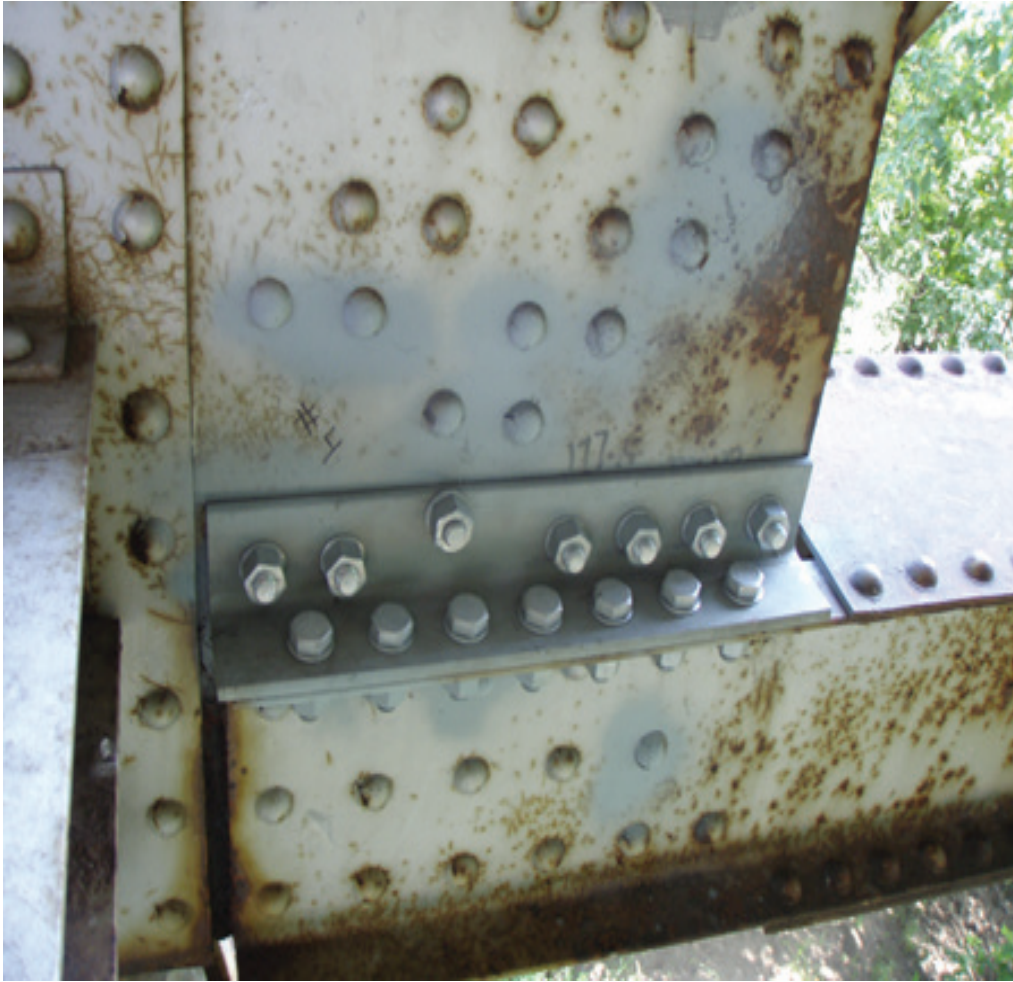
Figure 3-26—Localized angle repair to address section loss along the horizontal shear plane

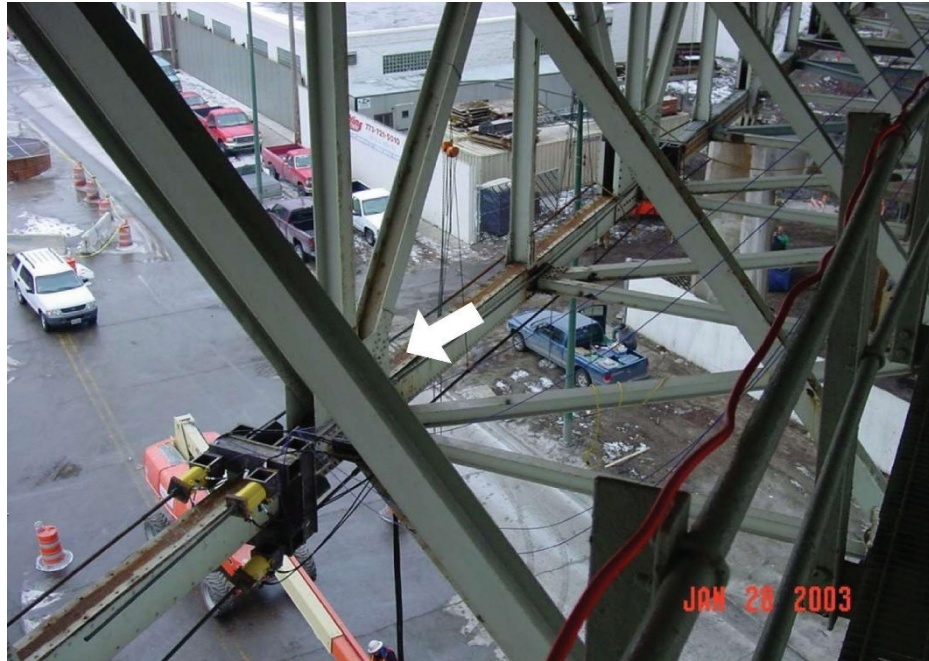
Figure 3-33—Supplemental tie rods to remove the existing load in the truss tension chord (arrow indicates gusset plate being repaired)

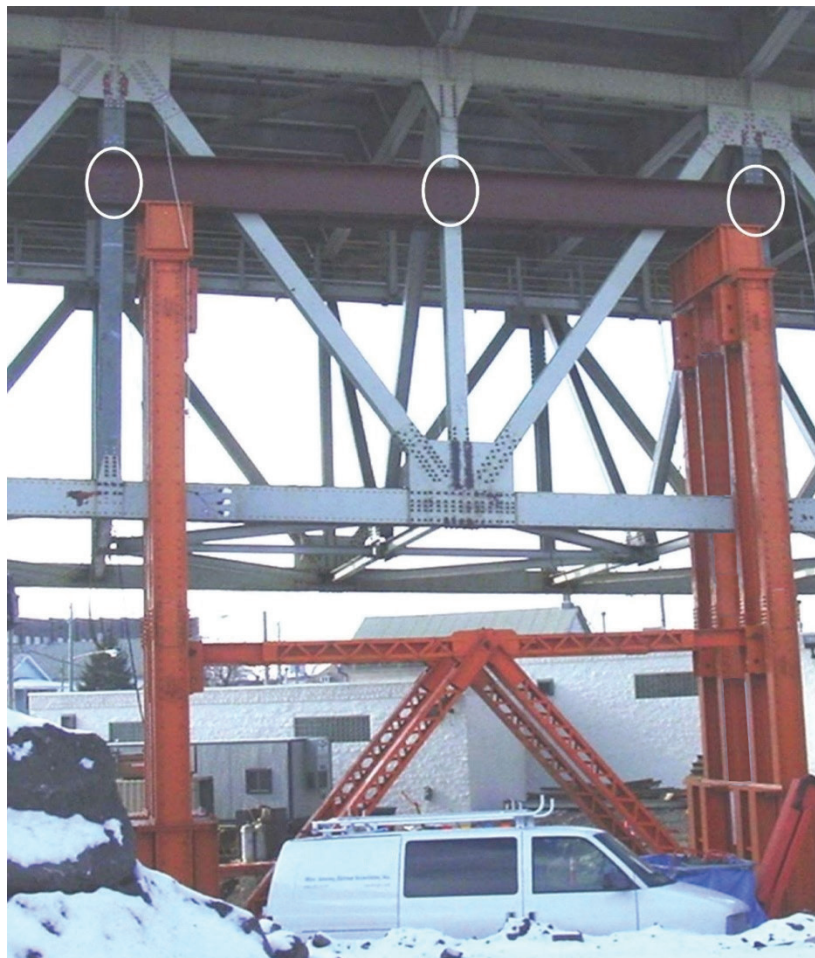
Figure 3-35—Example of supplemental truss shoring to perform a gusset plate replacement; circles indicate bolted connections for temporary truss support on the shoring tower header beam

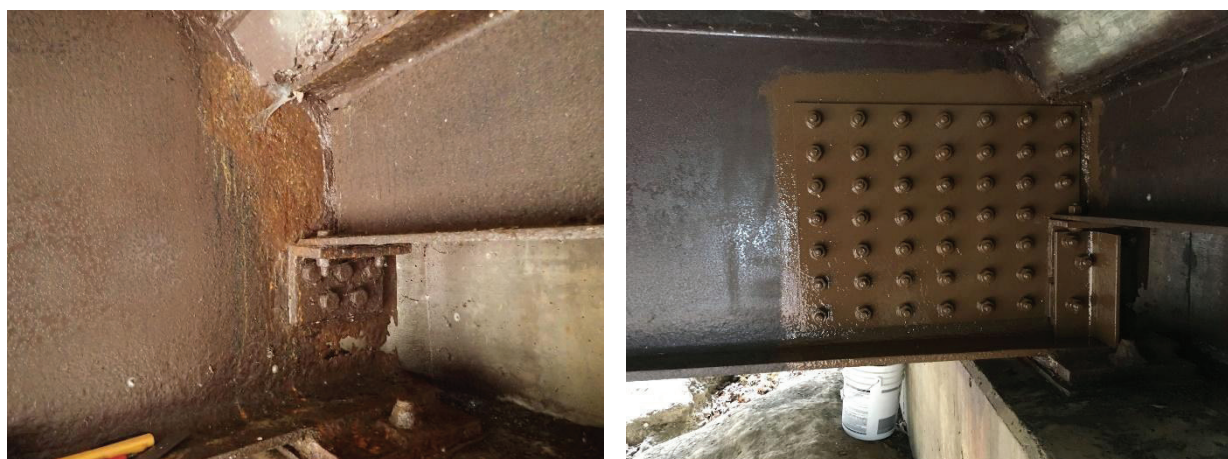
(a) Beam end with through-thickness section loss

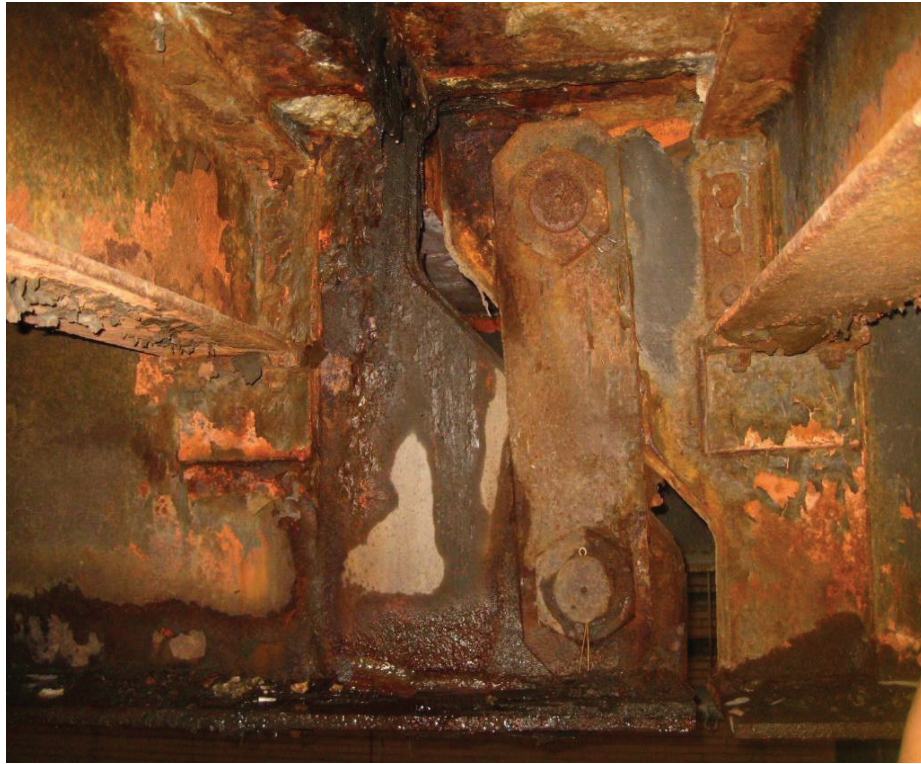
Figure 3-45—Severe corrosion of a pin and hanger connection that may create unintended torsional stress on the pin

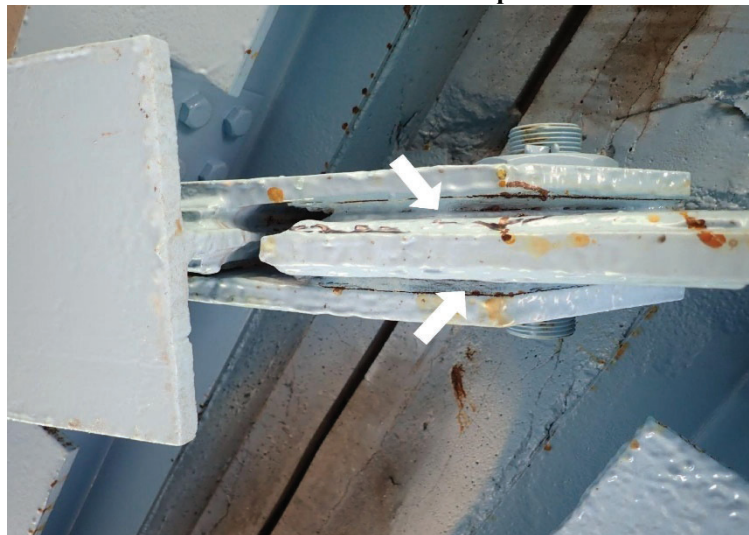
Figure 3-46—Pack rust between the pin plates (arrows) that creates unintended tensile stress in the pin

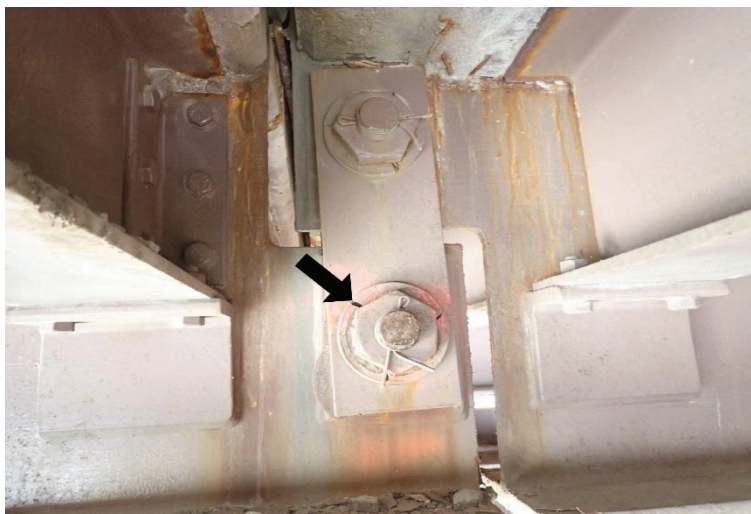
Figure 3-47—Broken spacer washers (arrow) in a pin and hanger connection

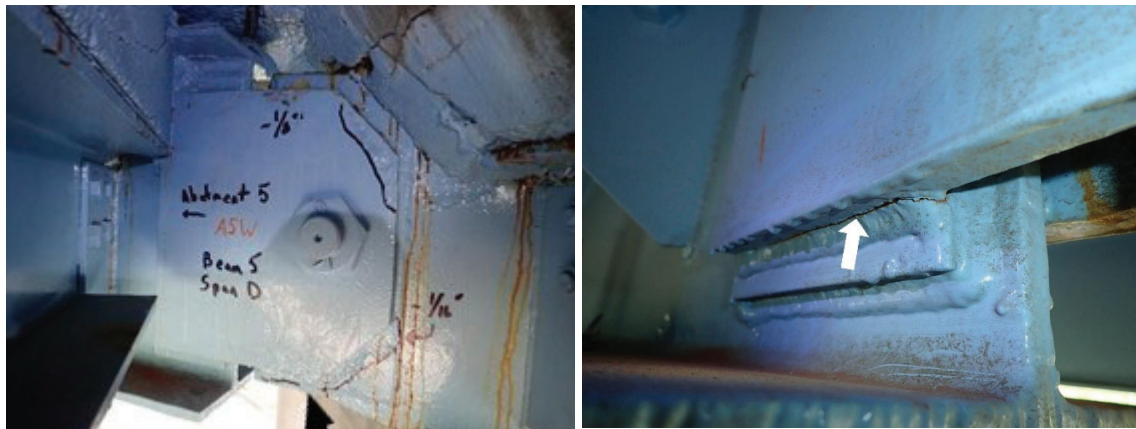
(a) Overall view; arrow shows the view of the close-up photo

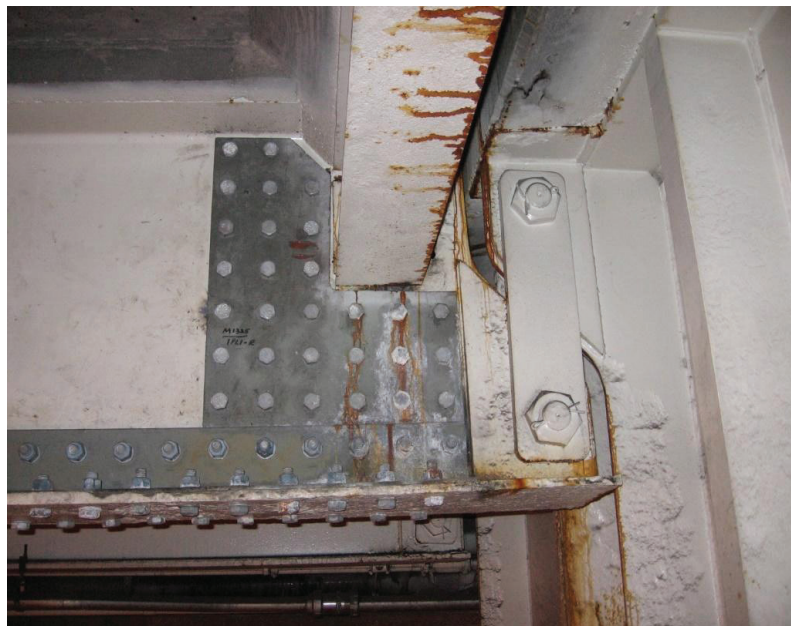
Figure 3-50—Plate strengthening repairs to address section loss of a girder web and flange adjacent to a pin and hanger connection

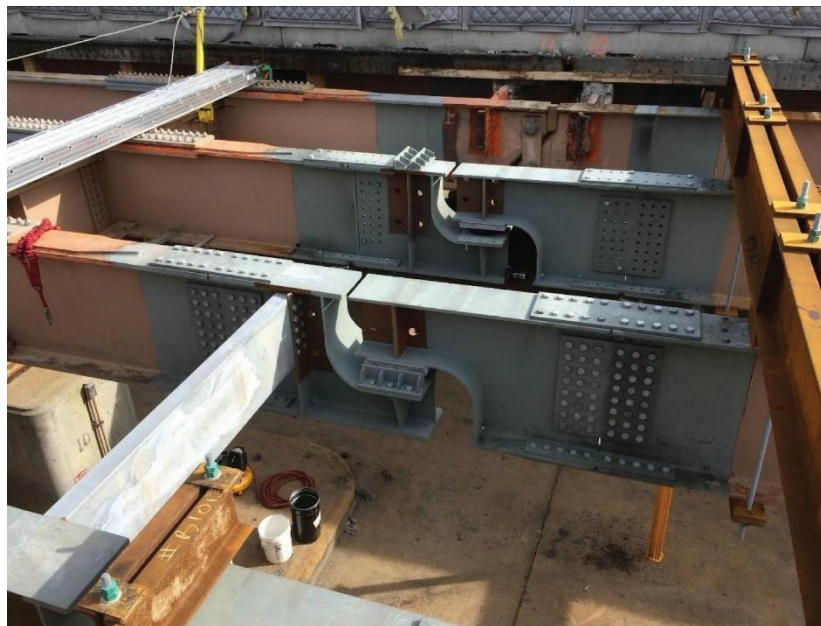
Figure 3-54—Example of a pin and hanger assembly replaced with seated beam connection (Linzell et al., 2017)

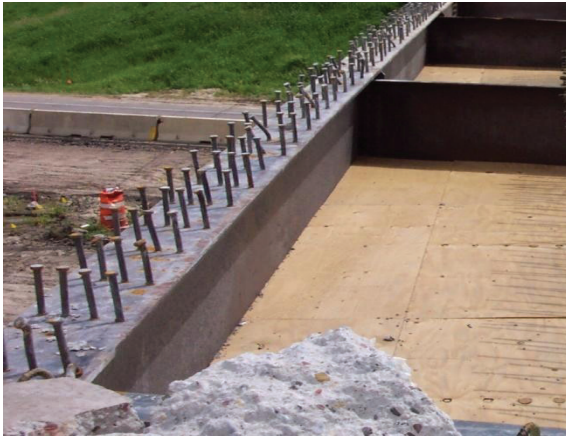
Existing shear connectors may be shear studs or channel lugs as shown in Figure 4-12. The Contract plans should identify the existing shear connector type to assist the Contractor in planning the deck removal. Any new shear connectors added to regions where shear connectors are already present should be detailed to accommodate the existing spacing and a reasonable placement tolerance should be provided to accommodate as-constructed conditions.

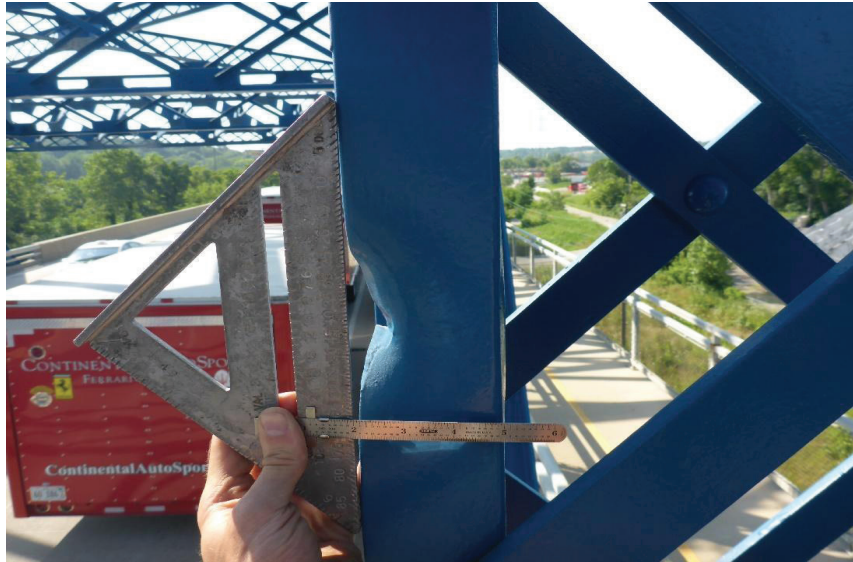
Figure 5-1—Local distortion of the projecting flange of a channel section used in a truss vertical member

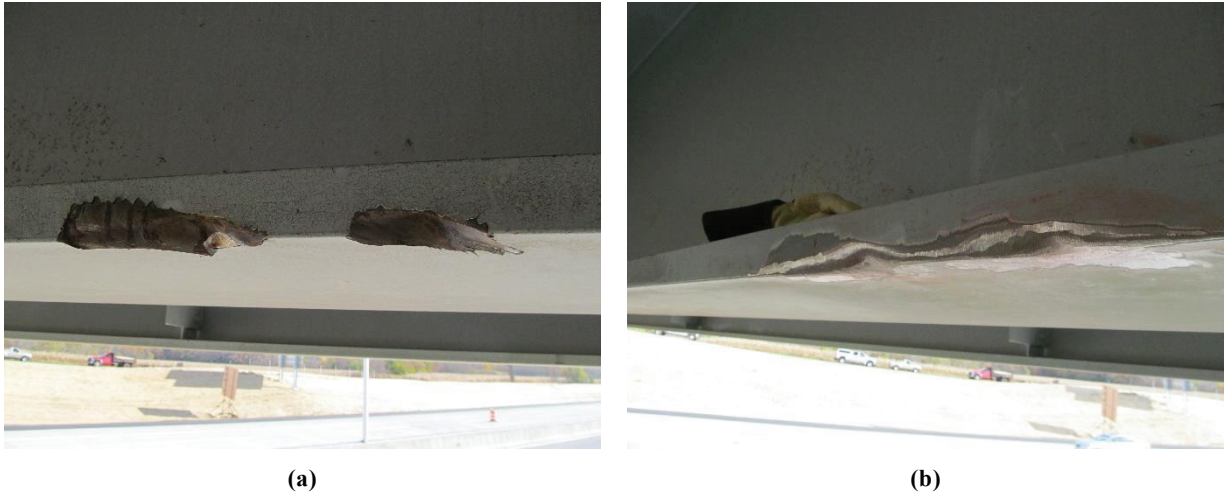
Figure 5-2—Gouging in a girder bottom flange (a) as discovered and (b) after grinding repairs

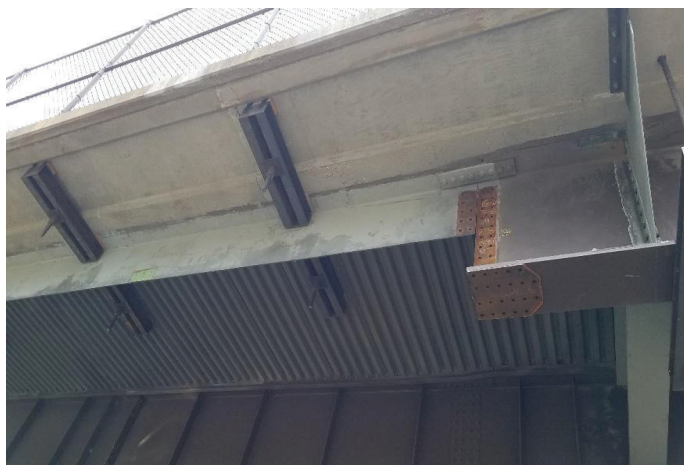
Figure 5-6—Partial-Depth Removal (Maryland Transportation Authority)

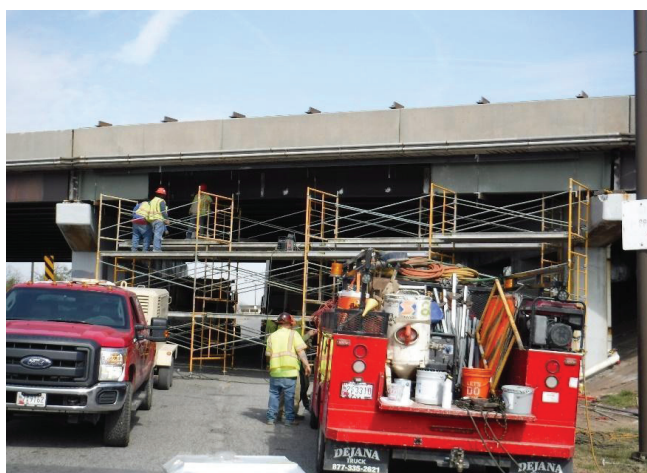
Figure 5-7—Full-Depth Removal (Maryland Transportation Authority)

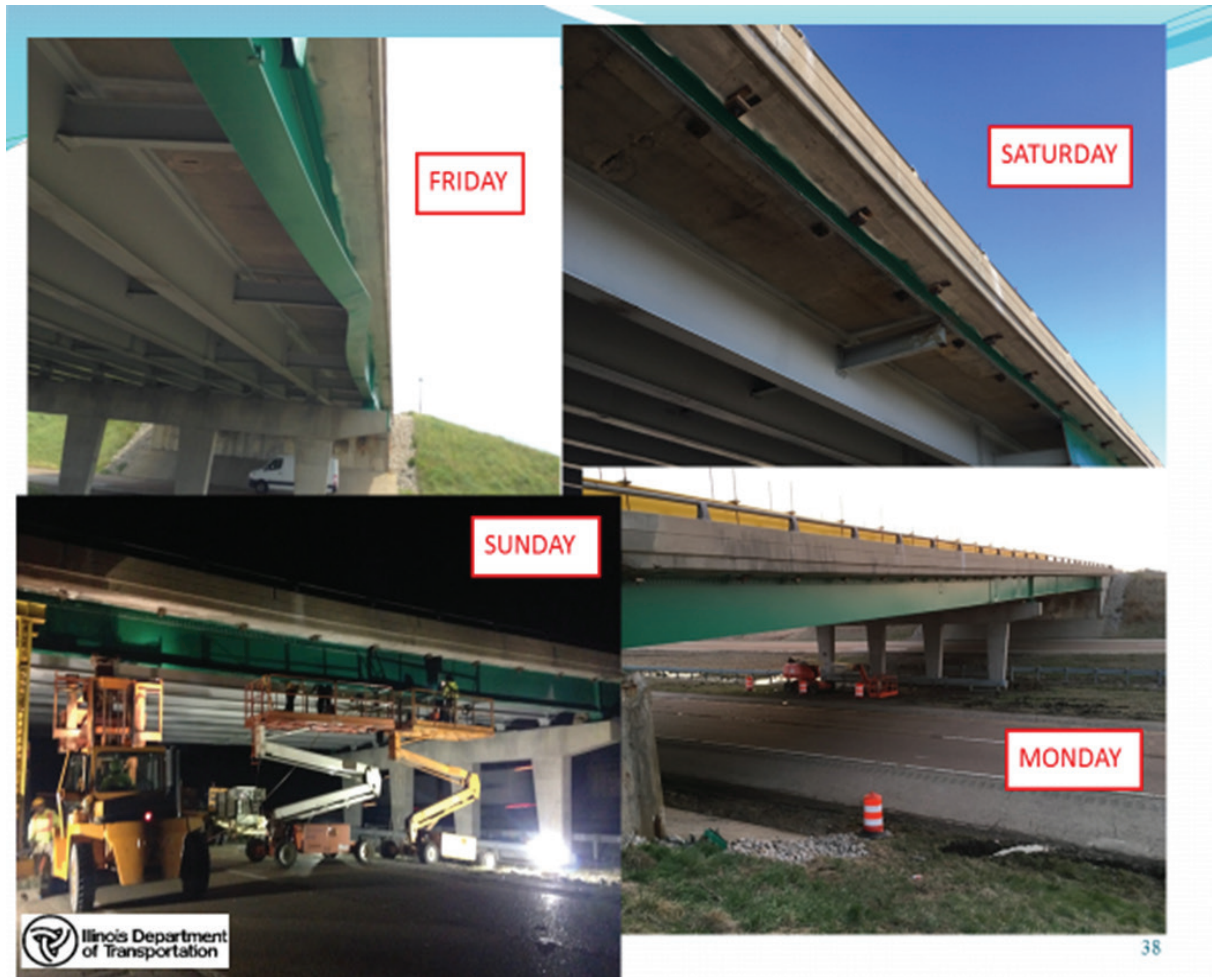
Figure 5-13—Photos illustrating primary stages of partial beam replacement (Illinois DOT)

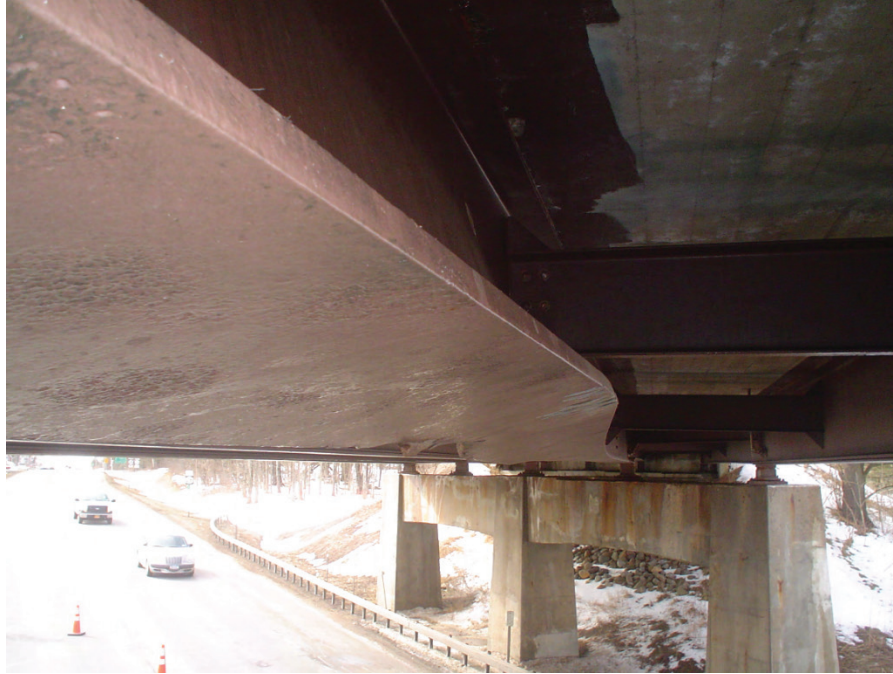
Figure 5-14—Impact damage to an interior steel girder of a multi-girder bridge

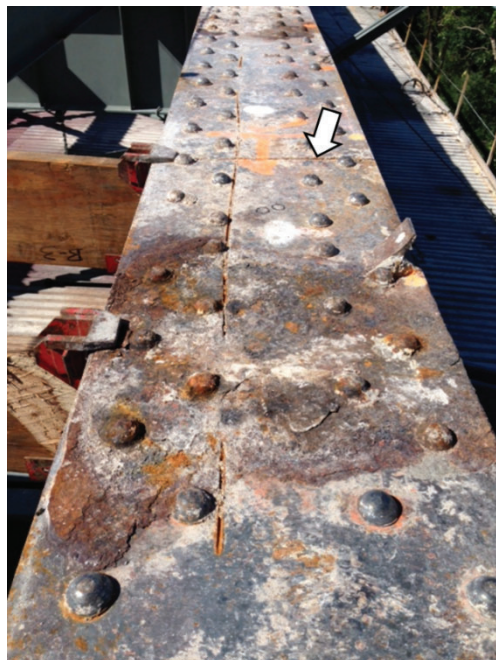
Figure 7-3—Example of a longitudinal saw cut in a built-up girder flange; arrow indicates a transverse saw cut

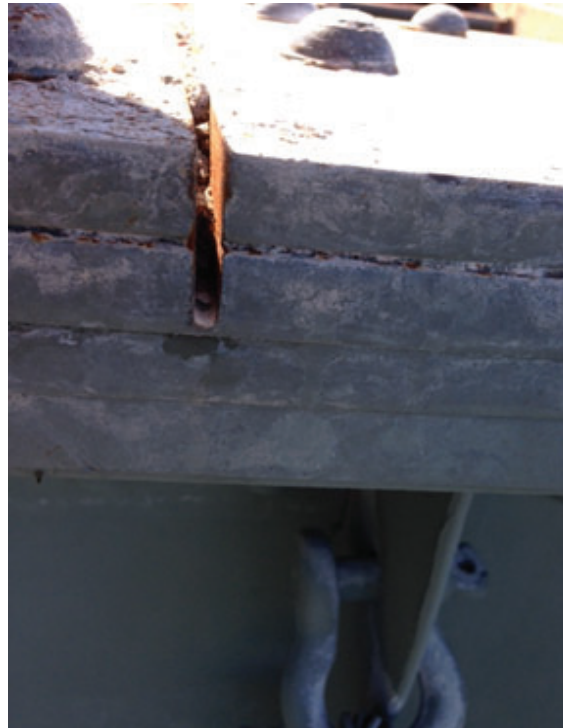
Figure 7-4—Saw-cut damage in a built-up top flange causing severing of the top plate and near-full section loss of the second plate from the top
