# MODERN STEEL CONSTRUCTION

VOLUME XIII / NUMBER 1 / FIRST QUARTER 1973

Steel Skylight Spans Stepped Studio	3
Raising the Roof at Buffalo	6
Disney World Hotel Assembled from Factory-Made Rooms	9
Fire in an Exposed Steel Parking Structure	12
1972 Architectural Awards of Excellence	15

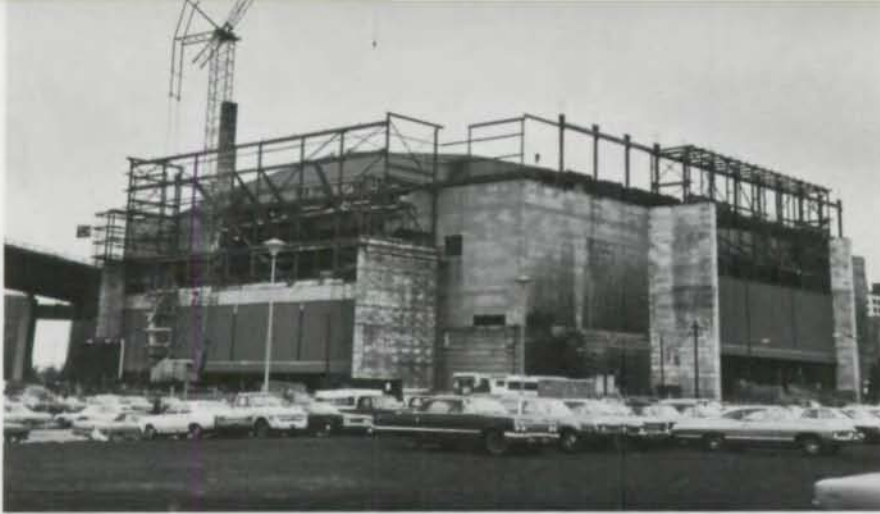
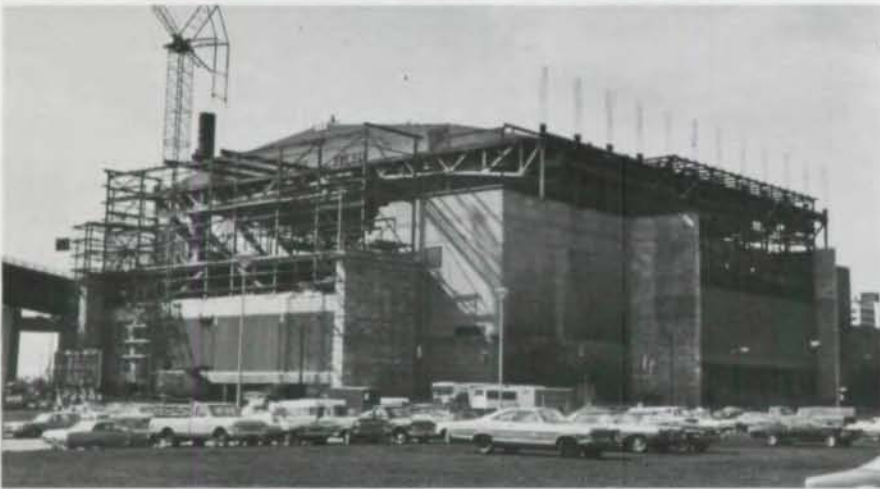
*Existing steel is extended upward, then roof is raised to new position.*

*Extended steel columns support the lifting jacks.*

The actual lifting of the roof was a climax to many weeks of careful preparation. Existing building steel was extended upward so that the new building columns could be used as a support for the lifting jacks. Holes were cut in the roof to facilitate the steel extension. The original design was ideally suited for repositioning the roof, since each end of each building truss was supported by a single 4½-in. steel pin extending through both the truss and the square building column. To expedite the removal of these pins at the actual time of the lift, each pin was removed and replaced with a slightly undersize pin for manual removal later on. Although it was anticipated that some difficulty might be involved in removing the original support pins, liberal lubrication and the use of hydraulic jacks, enabled the pins to be removed without difficulty. During the pin change, the roof itself was supported on the lifting jacks which had been positioned earlier.

The hydraulically-operated lift jacks were supported above the roof on top of the new building steel. A pair of jacks, each equipped with two lifting screws, was assembled on each column. Each of the individual assemblies was connected to two hydraulic consoles. Two separate assemblies were used for each side of the roof and were powered by two diesel engines.

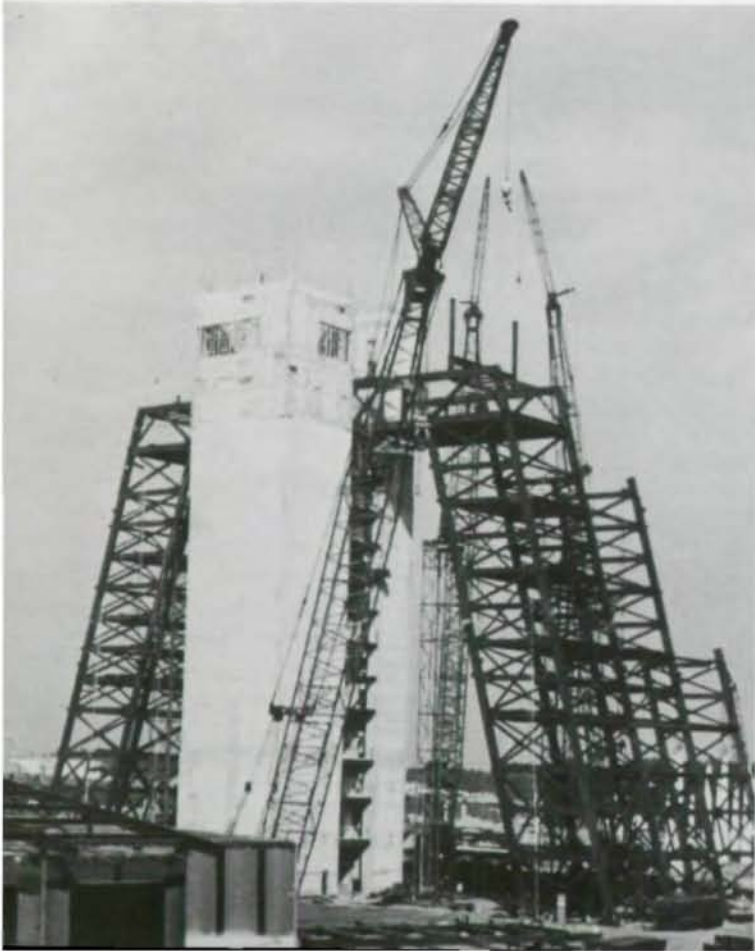
*Thirteen pairs of 150-ft high steel A-frames were erected around a central elevator core.*

*Preassembled two-room units "plug into" rectangular slots in steel framing.*

Except for some luxury suites on the 13th level, unitized steel construction is used for each hotel room from the 5th floor to the 12th floor on one side of the structure and from the 6th to the 12th floor on the other side. Each room module weighs 10½ tons — one-fifth the weight of equivalent sized modules made of concrete.

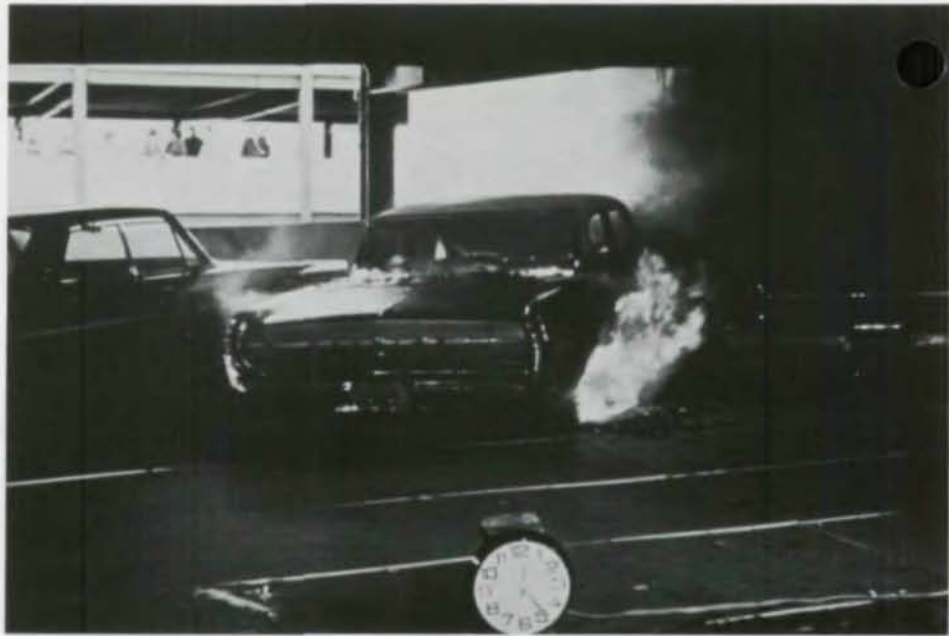
*Automobile burning 24 minutes into the test.*

Three automobiles were positioned, front first, into adjacent parking stalls, and spaced approximately 2 ft apart, as would normally be expected under actual conditions. In this position, the center car was located diagonally under an exposed girder, with its front in one bay and rear in another. The other two cars extended partially into other bays. The center car was then ignited.

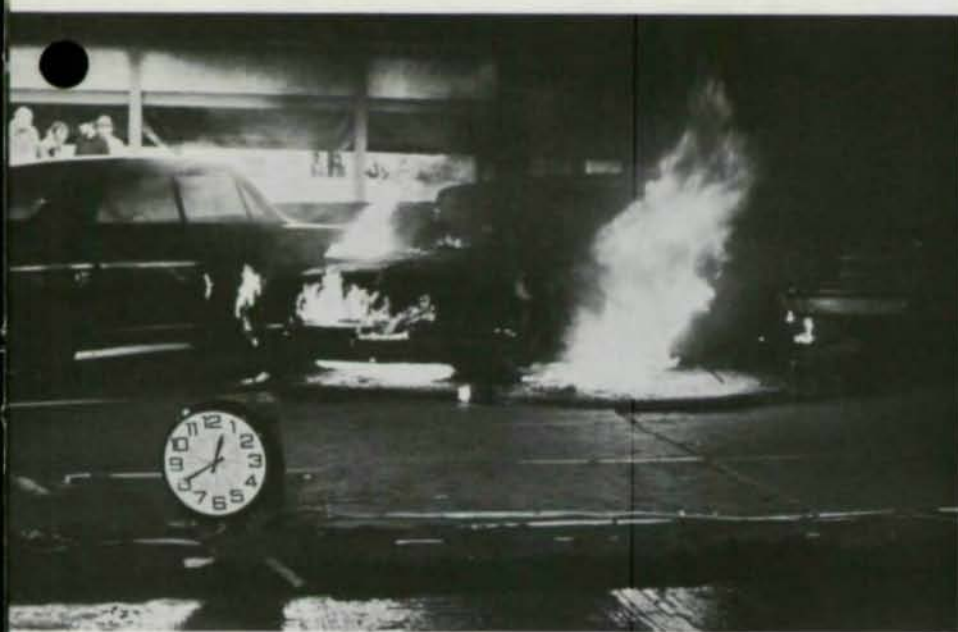
Automobile burning 42 minutes into the test.

For a short time, at 42 minutes into the fire, as gasoline under the test car was burning vigorously, the deflection at the center of the 54-ft long steel girder reached 1 $\frac{5}{8}$ -in., and its horizontal expansion measured  $\frac{1}{8}$ -in. These readings resulted entirely from thermal expansion of the bottom flange. After cooling, following the test, the structural element returned to its pretest condition, with deflection and elongation recorded at zero.

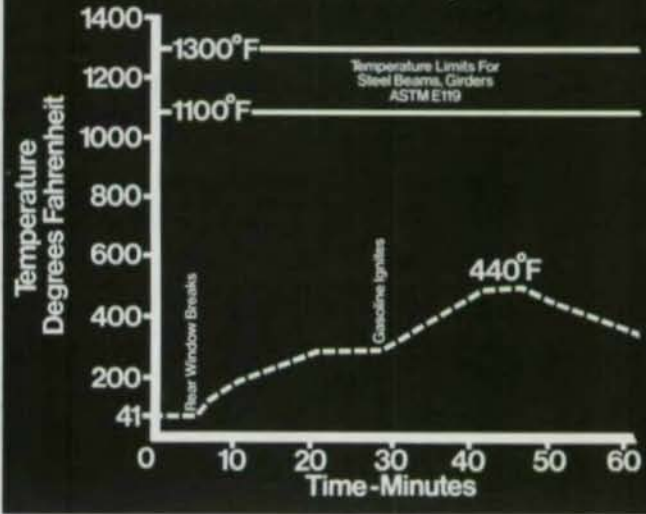
### Steel Girder Temperatures Over Gas Tank Scranton Fire Test - Oct. 15, 1972

**Instrumentation:** Temperatures in the test area were obtained from 40 thermocouples and recorded on charts at one 16-point and one 24-point temperature recorder. Placement of the thermocouples and recording of temperatures were accomplished by Underwriters' Laboratories, Inc. personnel.

Fire exposure to the exposed steel structural members was never a critical factor during the test. Maximum temperatures and deflection of the girder directly over the fire remained well below significant levels. There was no damage to the exposed steel.

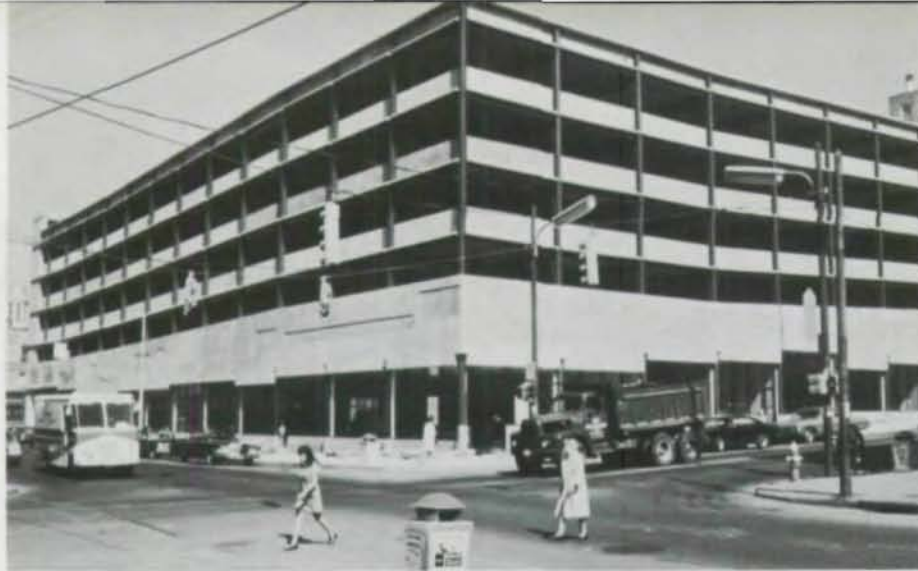
Exterior view of Scranton Parking Facility, site of full scale burnout test.
