# Let in the Sunshine

**Structural steel helped make this modern Native American health center a reality.**

**WITH A STUNNING 360-DEGREE VIEW OF THE SURROUNDING MOUNTAINS, THE NEW DULCE HEALTH CARE CENTER REPLACES AN OLD, CROWDED CLINIC.**

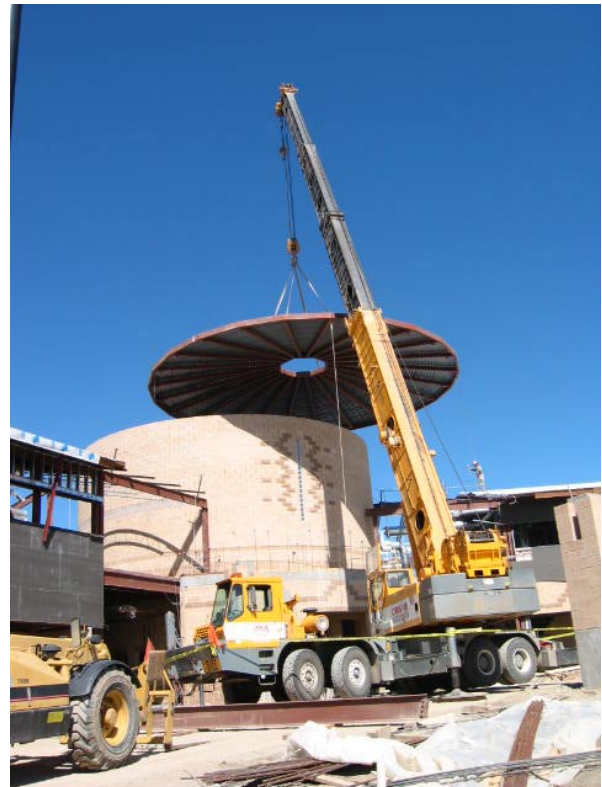
The circular rotunda roof, using HSS8x4x¼ joist members framing into HSS10x4x¼ tension and compression rings, was assembled on the ground and installed as a unit.

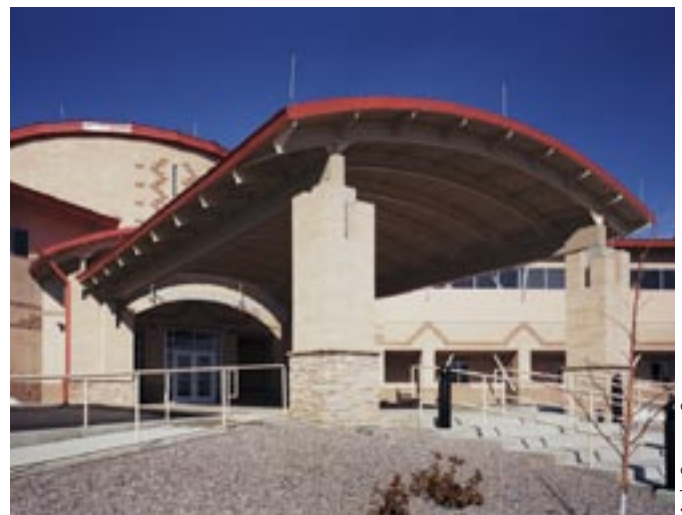
The principal entry to the clinic is on the east face of the 48-ft-diameter rotunda.

The principal entry to the clinic is on the east face of the rotunda. A sliver of sunlight slices thru the narrow aperture of rotunda wall greeting the public as they enter the rotunda. This 48-ft-diameter circular entry is constructed of split-face concrete masonry units and extends above the highest part of the building's roof. The rotunda is capped with a sloping roof and is punctuated by a central skylight allowing the natural sunlight to filter into the building in a soft glow.
