AISC 358: PREQUALIFIED MOMENT CONNECTIONS

BY RONALD O. HAMBURGER, S.E.

A look at prequalified connections for special and intermediate moment resisting frames for seismic applications.

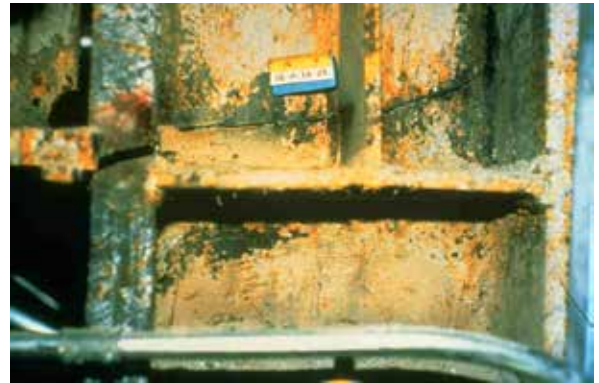
- ▲ Typical fracture of a beam's lower flange-to-column flange weld.
- ▼ Typical welded unreinforced flange, bolted web moment connection prescribed by pre-1997 building codes.

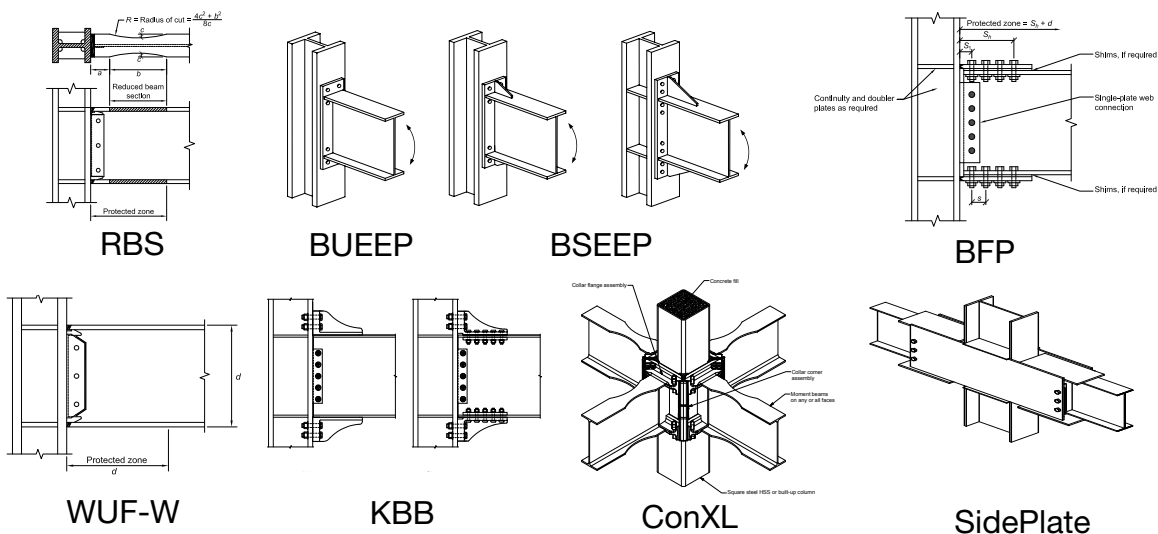
▲ Prequalified moment connections.

edition of AISC 358. This first edition included prequalification data and design procedures for three connection types: reduced beam section (RBS), bolted unstiffened extended end plate (BUEEP) and bolted stiffened extended end plate (BSEEP). These connections could be used to connect beams to the major axis of wide-flange columns but also permitted connection to built-up box columns, boxed wide-flange columns and cruciform wide-flange columns. The publication of AISC 358-05 made it practical, once again, for engineers to design code-conforming steel moment frame structures in regions of high earthquake risk.
