# REVISITING W1 INDICATIONS

BY DUANE MILLER, P.E.

Looking back can reveal how different our final conclusions are from our initial thoughts.

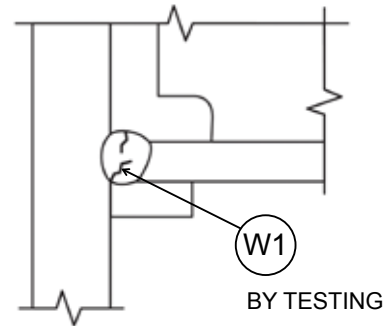
▼ The details of W1s as shown on inspections forms. W1s could be detected only “by testing.” (Adapted from SAC 94-01.)

FEMA 267 also separated W1s into two subdivisions: W1a and W1b. A W1a was defined as incipient indication with a depth of up to  $\frac{3}{16}$  in. or  $t_f/4$ , and a width of less than  $b_f/4$  in., while a W1b was a root indication larger than a W1a. This subdivision was used (in part) to separate pre-existing conditions from earthquake damage, as can be seen in this statement: “Some engineers believe that type W1a indications are not earthquake damage at all, but rather, previously undetected defects from the original construction process. A W1b indication is one that exceeds these limits but is not clearly characterized by one of the other types. It is more likely that W1b indications are the result of the earthquake than the construction process.”
